CaseStudy

Bacterial Resistant Belting – Tegel Chicken

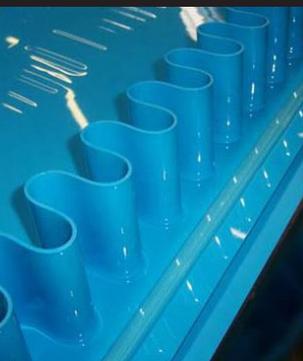
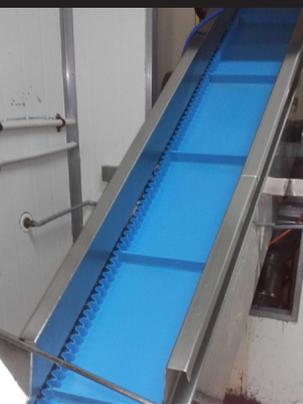
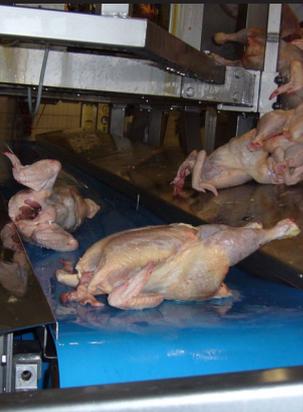
To resolve these issues, Tegel approached Viking Conveyor, who recommended a homogenous conveyor belt with high-frequency welded sidewalls and cleats, giving superior bond strength and long-term durability. The customer specifications called for 40mm sidewalls and cleats and fitted with a stainless steel fastener for quick and easy removal.

conveyor in product and chemicals, resulting in significant savings from quicker cleaning and lower sanitising costs. The extra clean-ability would also mean that there would be no discoloration of the conveyor, and the cleats and sidewalls were secure. After installation, a reduction in odour was noted and, most importantly, a significantly reduced bacteria count. This provided assurance that a healthy, hygienic solution had been delivered.
